**RICHARDSON FLATS TAILINGS SITE
SUMMIT COUNTY, UTAH
TDD #T08-9207-019**

**TAT Response to Pioneer Technical Services, Inc.
Comments and Observations Report
Dated July 13, 1992**

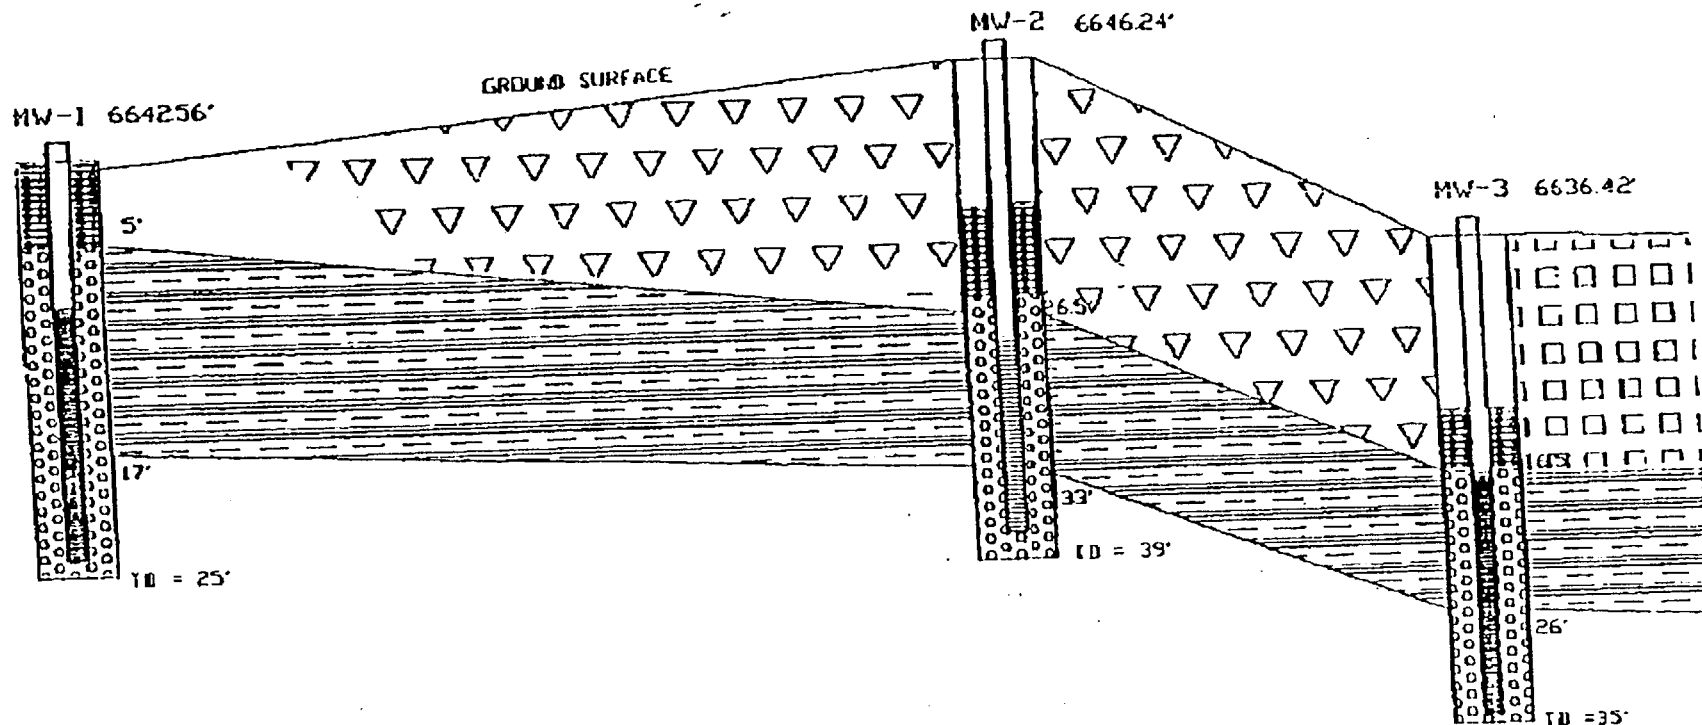
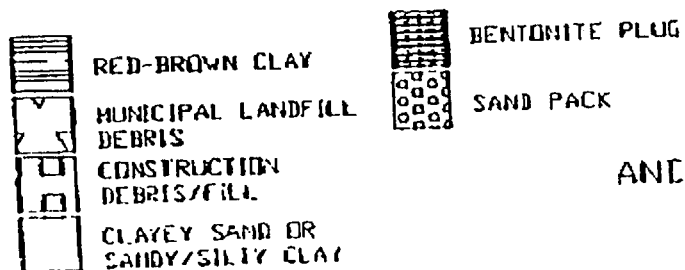
FIGURE 2
GEOLOGIC CROSS SECTION
AND LANDFILL MONITORING WELLS

This is the most egregious violation of sound hydrogeologic practice and may have violated State of Utah regulations for monitoring wells, water wells, or groundwater protection. The drilling of all three monitoring wells showed that the underlying groundwater was a confined or semi-confined aquifer system. In each borehole, the saturated zones were found beneath a thick, apparently continuous aquitard that isolated the landfill materials from underlying groundwater system (see cross-section, Figure 2). In each of the three monitoring wells, the static water level rose to an elevation significantly higher than the level at which water was first encountered.

After ill-advisedly locating well MW-2 within the former landfill (discussed above), drilling commenced. For whatever reason, the TAT did not closely monitor the drill cuttings from the borehole; however, UPCM's hydrogeologist was because of the geology observed at MW-1 and concern about breaching the aquitard underlying the landfill. At 25 ft bgs, a two-foot split spoon core revealed six inches of the aquitard (a reddish-brown clay) in the bottom of the core barrel, clearly showing the top of the aquitard to be at 25.5 ft bgs. The TAT erroneously recorded the top of this unit at 25 ft bgs. Drilling continued (slowly) and water was encountered between 34 and 35 ft bgs. The drilling was halted at 39 ft bgs and well completion activities began.

At this point, serious errors in judgment and perhaps criminal negligence, caused the completion of well MW-2 to be entirely inappropriate, if not illegal. First, 10 feet of screen were placed in the well, bringing the screened section up to 27.5 ft bgs, very close to the top of the aquitard unit. Then, the filter pack was brought up to 26 ft bgs, above the aquitard. The bentonite seal placed on top of the sand was intended to plug the aquitard; however, due to careless geologic logging, it completely missed the aquitard and provides no such seal. The formerly continuous barrier between the landfill materials and groundwater has been breached by the drilling and not repaired during well construction. Water level measurements on subsequent days show clearly that the underlying water is under pressure and has risen up the borehole to exactly 26.5 ft bgs, the top of the aquitard. The underlying groundwater is now flowing up the well under pressure, out through the filter pack along the top of the clay aquitard and into the base of the formerly dry landfill. When this water discharges from the base of the landfill, either as springs or to Silver Creek, it will be contaminated by whatever is in the landfill.

Prior to the installation of well MW-2, the landfill was isolated from the groundwater system. EPA and their TAT contractor have breached this natural compacted clay barrier and are thus solely responsible for the ensuing potential groundwater and surface water contamination.

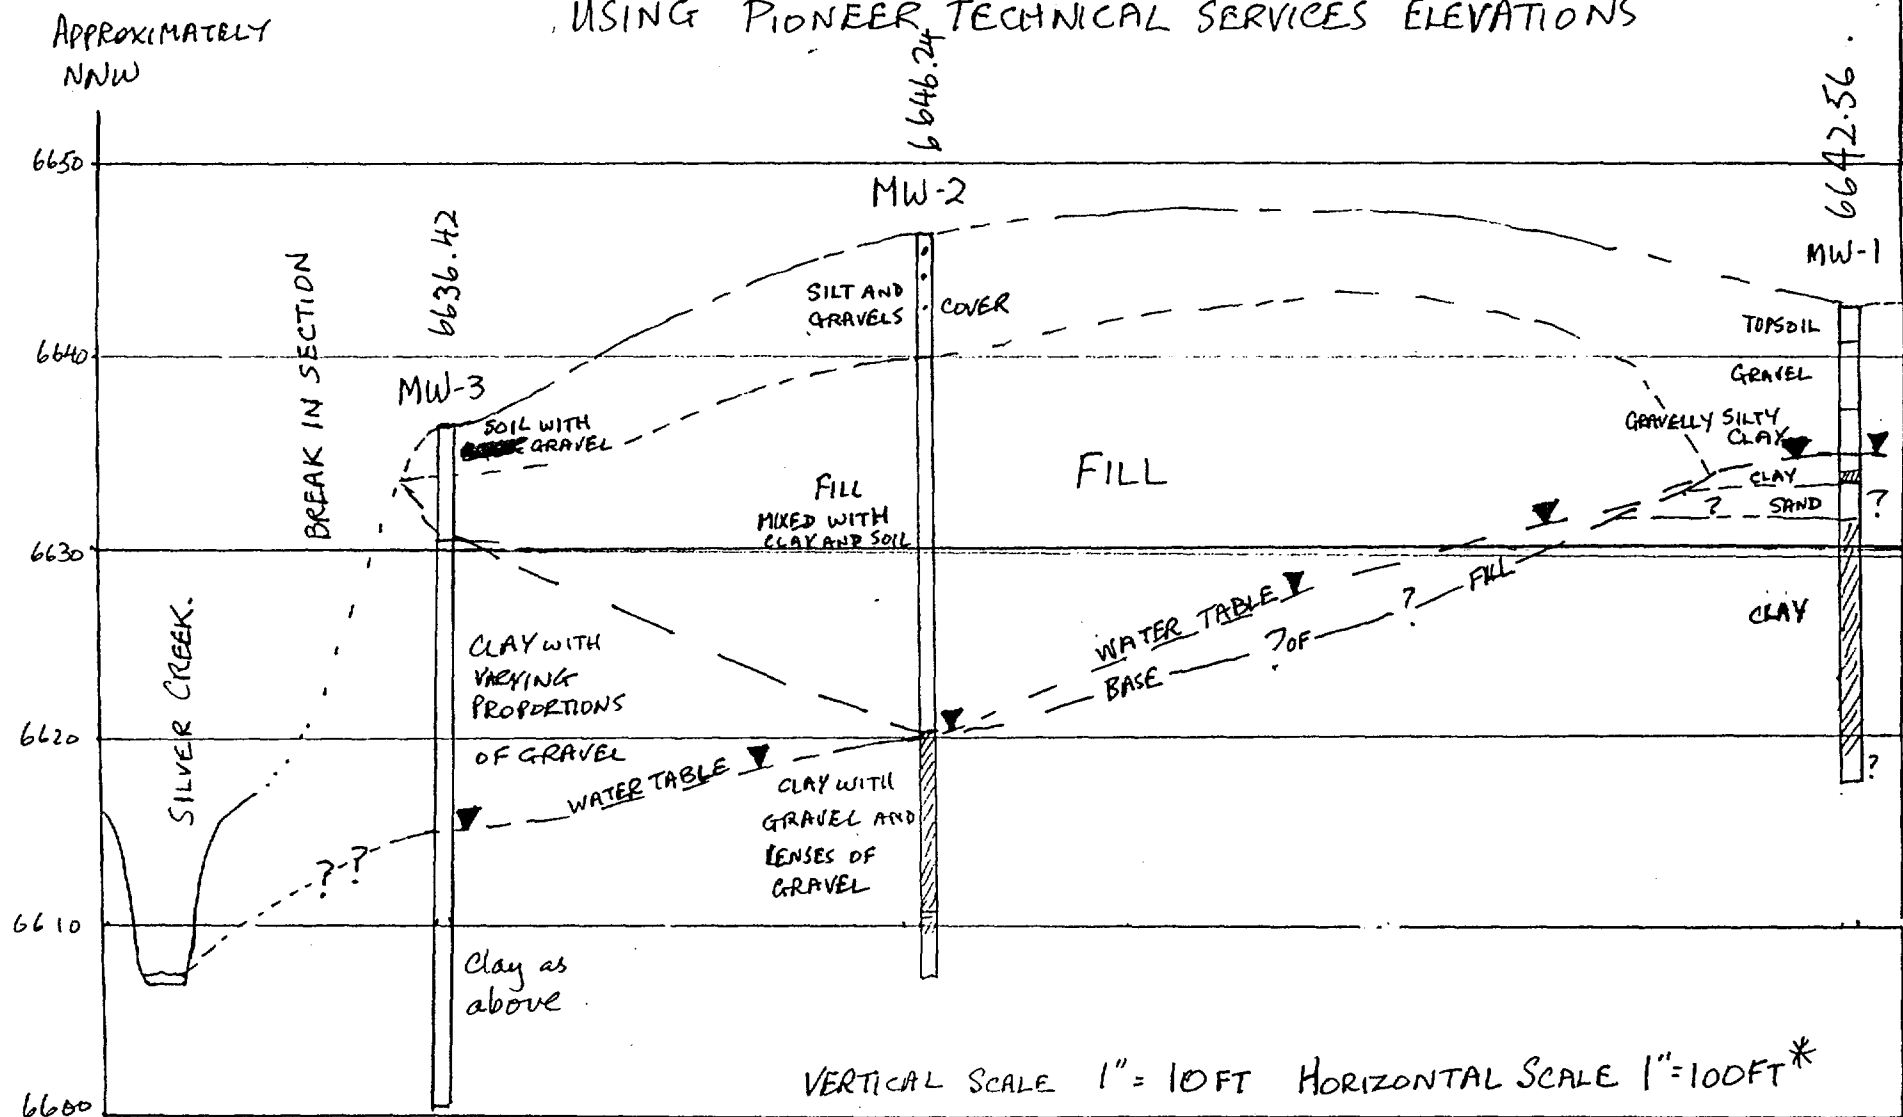
RICHARDSON FLATS TAILINGS SITE - SUMMIT CO. UTAH
 CROSS-SECTION THROUGH TAT BOREHOLES
 USING PIONEER TECHNICAL SERVICES ELEVATIONS

Very typically when drilling into sediments such as clay, the water table is not obvious during boring, and obviously saturated conditions are not encountered until well beneath the subsequently determined water table elevation.

This is because the rate of flow of water into the borehole is slight, especially because of the compression of clays ^{against} the borehole wall. Also, with the method of drilling used, the upper parts of the hole are cased off. When left open for some time or when completed as a well, the slow leakage of water from the borehole wall results in the gradual rise of the water until equilibrium is established.
